**Flood Control Project Maintenance
Levee Inspections**

Maintenance Issue Types Only, Levee Inspection Report By Mile - Spring 2018

Sutter Maintenance Yard Maintenance Area 0003

Waterway	Bank	Unit Miles	Inspection Start/End	Inspector
Unit No. 01 Feather River	Right	5.11	03/22/2018 03/22/2018	Sterling York

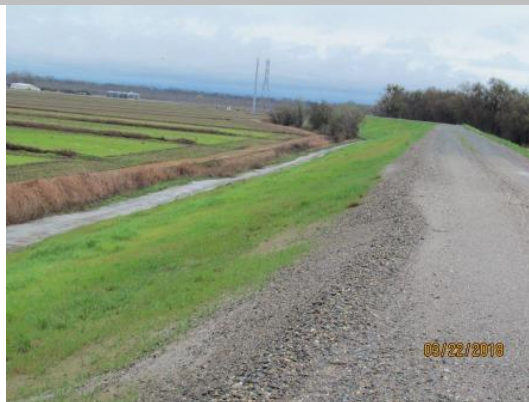
Photo 1 of 1 : SP_2018_MA0003_195_11_20180402_00027.jpg

LM Start	0.01	Rating **	A	Issue No.	11
LM End	5.11	Issue Type +	Ma	Location *	LS
Category	Earthen Levee			GPS Latitude/Longitude	
				Start	End
Item	Vegetation			38.898052 °	38.950950 °
				-121.617932 °	-121.585779 °
DWR ID	DWR_MA0003_01_s_2018_11				
Comment Code					
V1 : Control annual grass and weeds on the levee slopes and easements.					
Inspector Comment					
Annual vegetation is well maintained, Spring 2018.

View looking upstream landside of the well maintained vegetation, Spring, 2018.

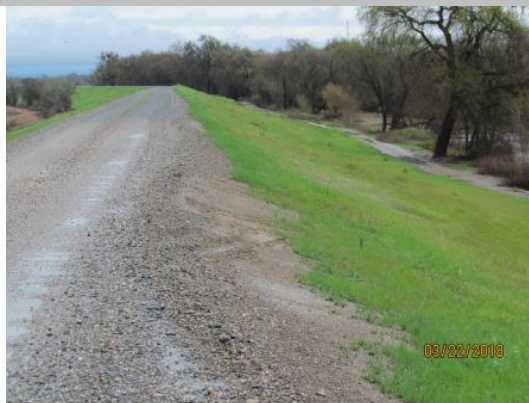
Photo 1 of 1 : SP_2018_MA0003_195_12_20180402_00028.jpg

LM Start	0.01	Rating **	A	Issue No.	12
LM End	5.11	Issue Type +	Ma	Location *	WS
Category	Earthen Levee			GPS Latitude/Longitude	
				Start	End
Item	Vegetation			38.898051 °	38.950950 °
				-121.617931 °	-121.585779 °
DWR ID	DWR_MA0003_01_s_2018_12				
Comment Code					
V1 : Control annual grass and weeds on the levee slopes and easements.					
Inspector Comment					
Annual vegetation is well maintained, Spring 2018.

View looking upstream waterside of the well maintained vegetation, Spring, 2018.

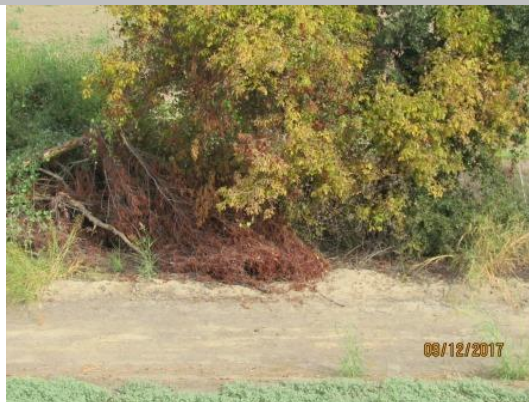
Photo 1 of 3 : SP_2018_MA0003_195_17_20180302_00007.jpg

LM Start	0.69	Rating **	M	Issue No.	17
LM End	0.69	Issue Type +	Ma	Location *	LS
Category	Earthen Levee			GPS Latitude/Longitude	
				Start	End
Item	Animal Control			38.903352 °	38.903352 °
				-121.607829 °	-121.607829 °
DWR ID	DWR_MA0003_01_s_2017_17				
Comment Code					
A1 : Exterminate rodents and backfill and compact or grout burrows.					
Inspector Comment					
A large hole on the lanside that look to be from a large animal needs to be repaired, Fall 2017.

View of the existing animal hole that is on the outside edge of the landside patrol road needs to be repaired. It is outside the levee prism, but should be monitored, Fall 2017.

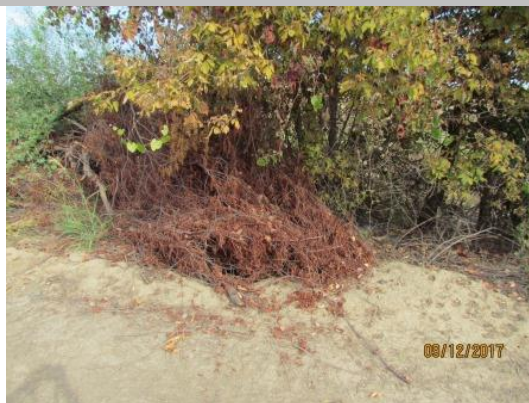
Photo 2 of 3 : SP_2018_MA0003_195_17_20180302_00008.jpg

LM Start	0.69	Rating **	M	Issue No.	17 (cont)	
LM End	0.69	Issue Type +	Ma	Location *	LS	
Category	Earthen Levee			GPS Latitude/Longitude		
				Start		End
Item	Animal Control			38.903352 °		38.903352 °
				-121.607829 °		-121.607829 °
DWR ID	DWR_MA0003_01_s_2017_17					
Comment Code						
A1 : Exterminate rodents and backfill and compact or grout burrows.						
Inspector Comment						
A large hole on the lanside that look to be from a large animal needs to be repaired, Fall 2017.

The existing animal hole that is on the outside edge of the landside patrol road does not appear to have any recent animal activity, Fall 2017.

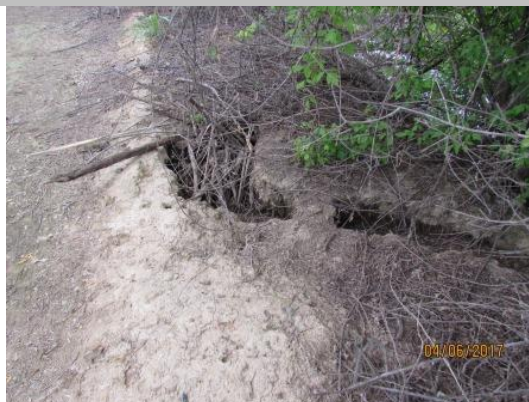
Photo 3 of 3 : SP_2018_MA0003_195_17_20180302_00009.jpg

View of a large hole on the landside that look to be from a large animal, Spring 2017.

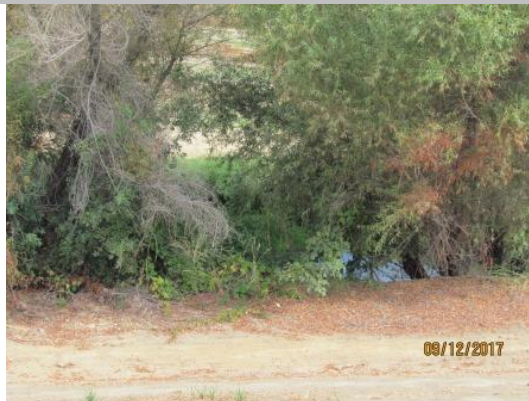
Photo 1 of 2 : SP_2018_MA0003_195_140_20180302_00013.jpg

LM Start	0.78	Rating **	A/W	Issue No.	140
LM End	0.78	Issue Type +	Ma	Location *	LS
Category	Earthen Levee			GPS Latitude/Longitude	
				Start	End
Item	Animal Control			38.903339 °	38.903339 °
				-121.606209 °	-121.606209 °
DWR ID	DWR_MA0003_01_f_2014_140				
Comment Code					
A3 : No rodents visible, but rodent burrows visible; need to backfill and compact or grout burrows.					
Inspector Comment					
The rodent hole on the landward toe road approximately 8" in diameter tis no longer there but should be monitored. Fall 2017.

View of were the rodent hole has been repaired, Fall 2017.

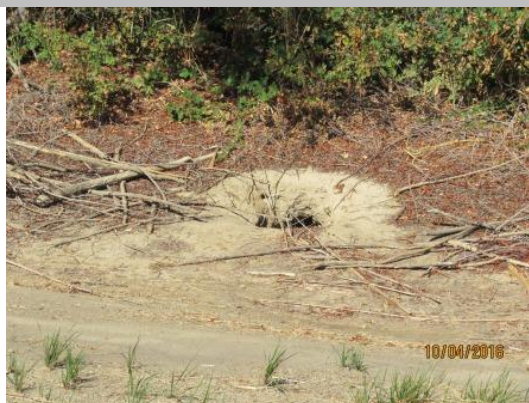
Photo 2 of 2 : SP_2018_MA0003_195_140_20180302_00014.jpg

This photo was taken from the landward levee slope near the toe road facing north looking at an approximately 8" rodent hole. Fall 2016.

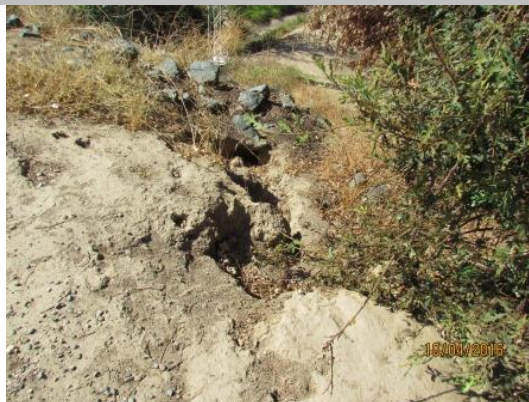
Photo 1 of 1 : SP_2018_MA0003_195_18_20180302_00010.jpg

LM Start	2.18	Rating **	A/W	Issue No.	18
LM End	2.18	Issue Type +	Ma	Location *	LS
Category	Earthen Levee			GPS Latitude/Longitude	
				Start	End
Item	Animal Control			38.911869 °	38.911869 °
				-121.586093 °	-121.586093 °
DWR ID	DWR_MA0003_01_s _ 2015_18				
Comment Code					
A3 : No rodents visible, but rodent burrows visible; need to backfill and compact or grout burrows.					
Inspector Comment					
No animal activity, Fall 2017.

View of rodent holes that need to be backfilled, No evidence of rodents during inspection. Fall 2016.

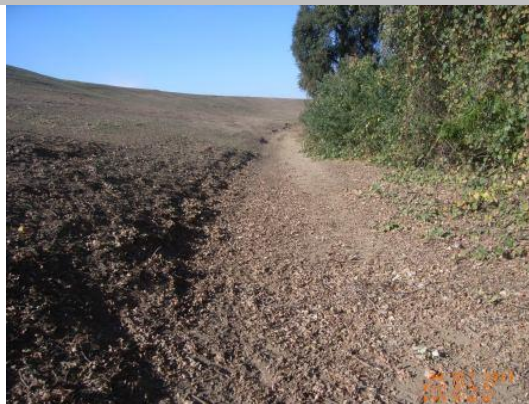
Photo 1 of 2 : SP_2018_MA0003_195_2_20180302_00003.jpg

LM Start	4.71	Rating **	M	Issue No.	2
LM End	4.76	Issue Type +	Ma	Location *	WS
Category	Supplemental			GPS Latitude/Longitude	
				Start	End
Item	2015 USACE Erosion Survey, DRAFT			38.945188 °	38.945958 °
				-121.586096 °	-121.586394 °
DWR ID	DWR_MA0003_01_s_2016_2				
Comment Code					
Inspector Comment					
2013 - Minor toe scour causing gradual erosion into the bank slope.					
2015: Last observed in 2013. [2015 Site ID: FHR_12-8_R]
